TAUNTON RIVER BASIN
BROCKTON, MASSACHUSETTS

THIRTY ACRE POND DAM
MA 00423

PHASE I INSPECTION REPORT
NATIONAL DAM INSPECTION PROGRAM

MAY 1979

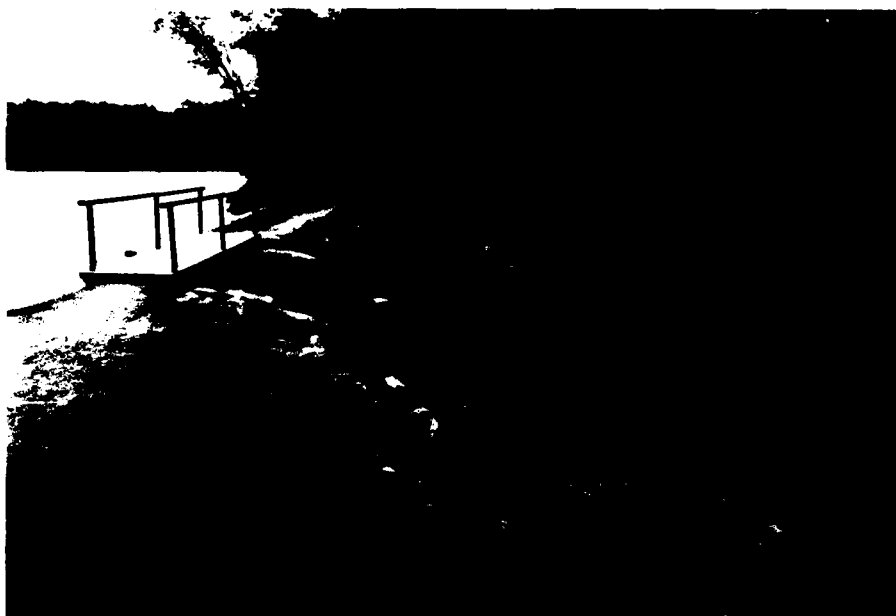
1. Overview of dam from right abutment.

- (1) The top of the dam embankment at the right end is bare, and a bare path at least 4 ft wide has been worn along the axis for the entire length of the crest, as shown in Photos 1, 2 and 3. Grass on either side of the path was mowed. Both the upstream and downstream slopes of the embankment are covered by brush and trees, some of which are as large as 12 in. in diameter, as shown in the same photos. Sand and gravel fill with cobbles and boulders is exposed on the downstream slope around the trees. Localized erosion of the slope was observed where there is no vegetative cover. Part of the length of the upstream face is protected by cut stone masonry walls and part by broken rock and boulders, as shown in Photo 3.

2. Reshape the downstream embankment slope and place topsoil as necessary to establish and maintain vegetative cover.
 3. Repair local eroded areas in the embankment and establish turf on the crest to resist erosion. If foot traffic does not permit such a growth, the trafficked areas should be protected by other means, such as pavement or crushed stone.

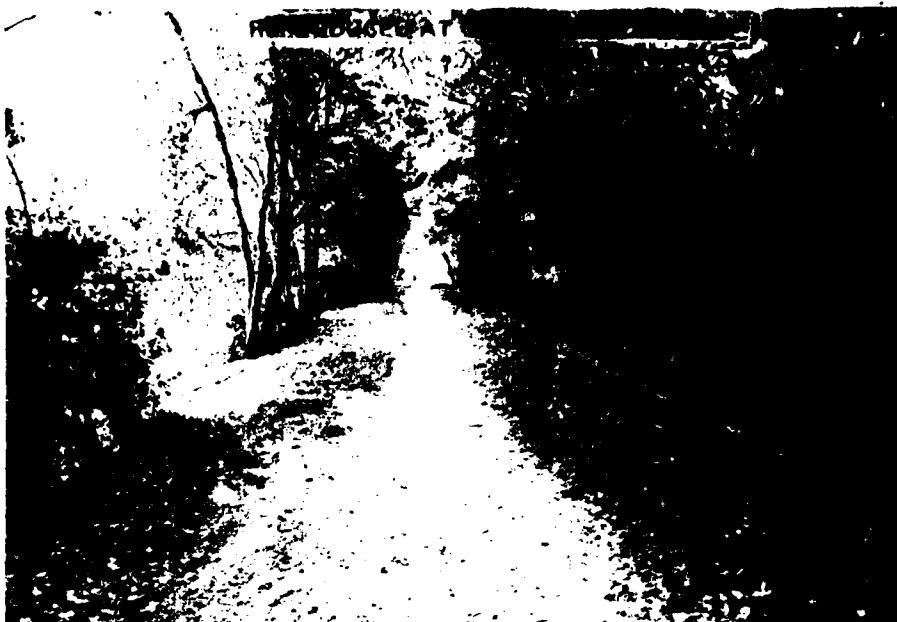
3. Crest of dam looking east.

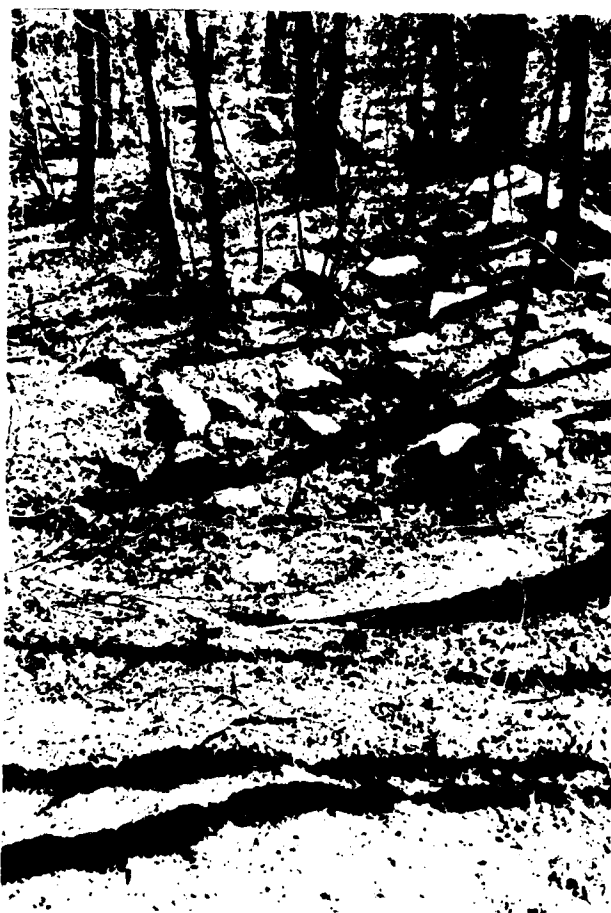
(c) At the downstream toe of the embankment within 200 ft to the right of the spillway outlet pipes, there are several wet areas at the location shown in Photo 4. The bed of these areas is again stained a reddish-brown color and the combined flow from the areas to a stagnant pool located about 40 ft downstream of the toe was estimated to be about one gallon per minute at the time of the visual inspection.

This condition was observed to be more active on 23 March 1979 during a supplemental visit to the site, when the level of the pond was 0.5 ft higher. Seepage flow was emerging approximately 100 ft right of the pipes near the downstream toe. At that time, the seepage rate at this specific location was estimated to be less than one gallon per minute. Soil particles were not observed in the seepage flow.

4. Downstream toe of dam in seepage area.

1. Assess the potential for a failure and/or excessive movement of the dam and dike embankments under earthquake loading conditions for Seismic Zone 3.
2. Investigate the seepage condition near the downstream toe of the embankment and assess the need for remedial measures. The investigation should include systematic monitoring of the seepage at the base and lowest berm of the ornamental embankment at the emergency spillway, at the service spillway discharge pipes, and near the downstream slope right of the pipes. Particular attention should be paid to the possible presence of soil

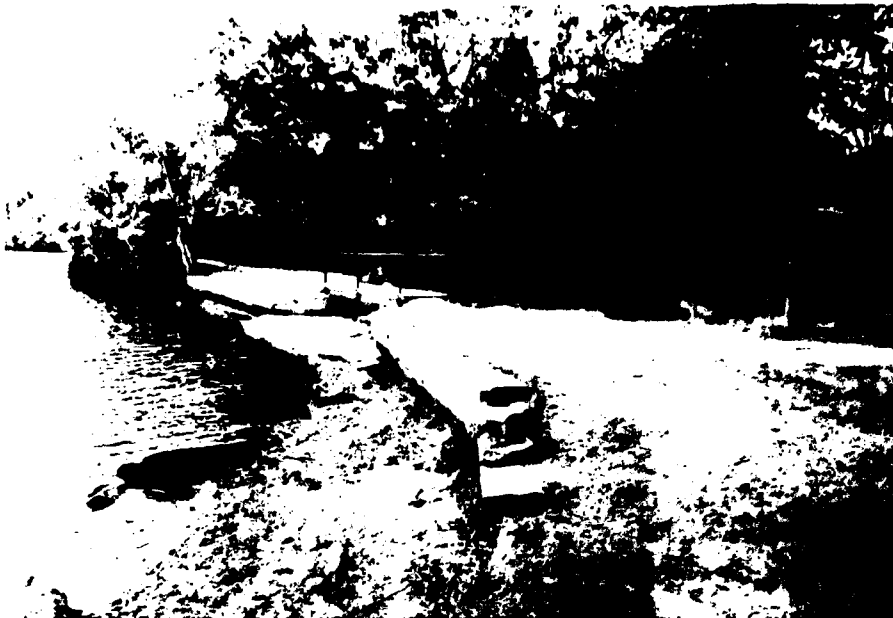
(5) Minor undercutting of the aprons is occurring at the right spillway and the entrance stone walls have some loose and/or missing mortar at the joints.

5. Upstream side of emergency spillway.

4. Repair the eroded concrete invert and patch the concrete spalls in the service spillway intake.
 5. Repoint the stonework at the front of the emergency spillway.

6. Fill all undercut areas with concrete at the upstream and downstream aprons of the emergency spillway.
 7. Prepare an operations and maintenance manual for the dam. The manual should include provisions for annual technical inspection of the dam and for surveillance of the dam during periods of heavy precipitation and high reservoir water levels; special attention should be given to monitoring seepage conditions and the removal of stoplogs during major flooding events. The manual should delineate the

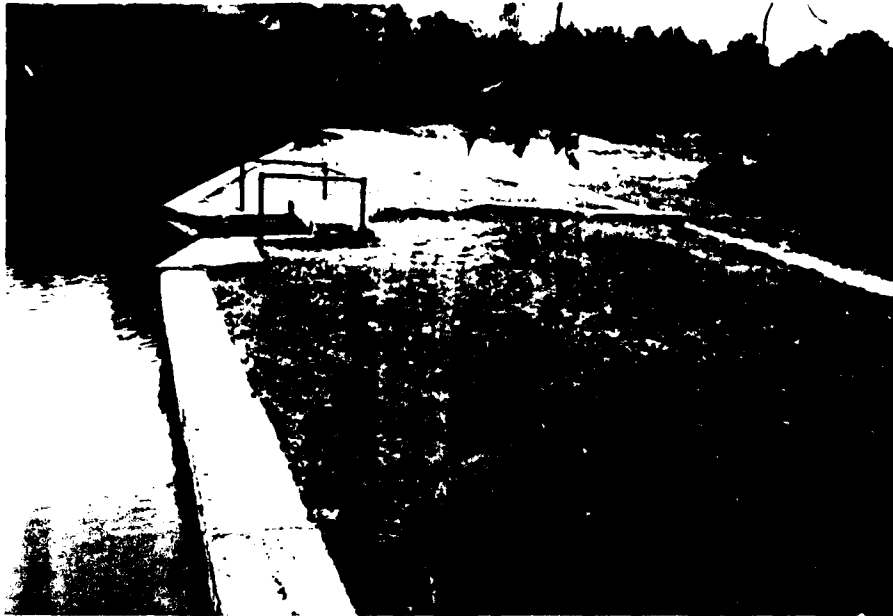
7. Entrance of service spillway.

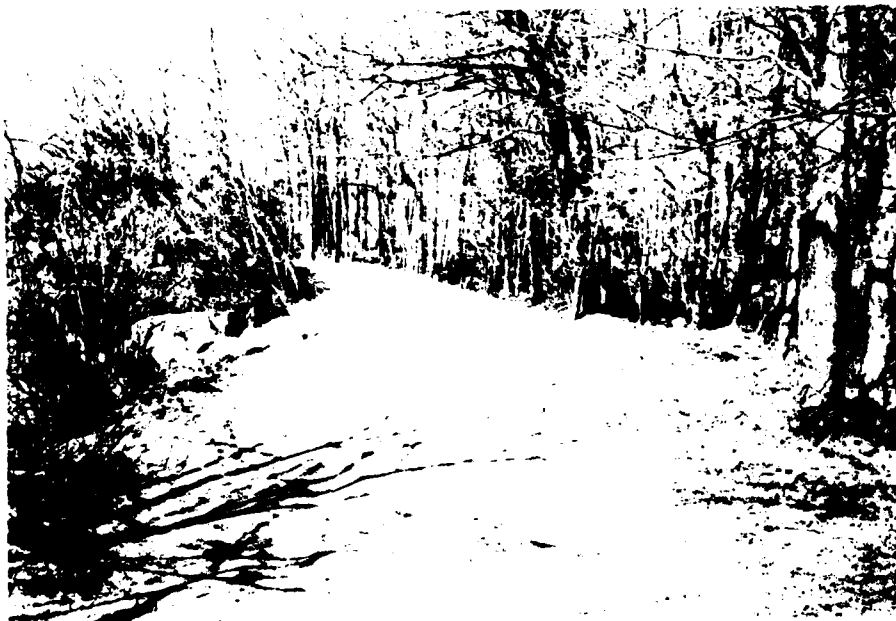
10. Crest of low dike left of dam.

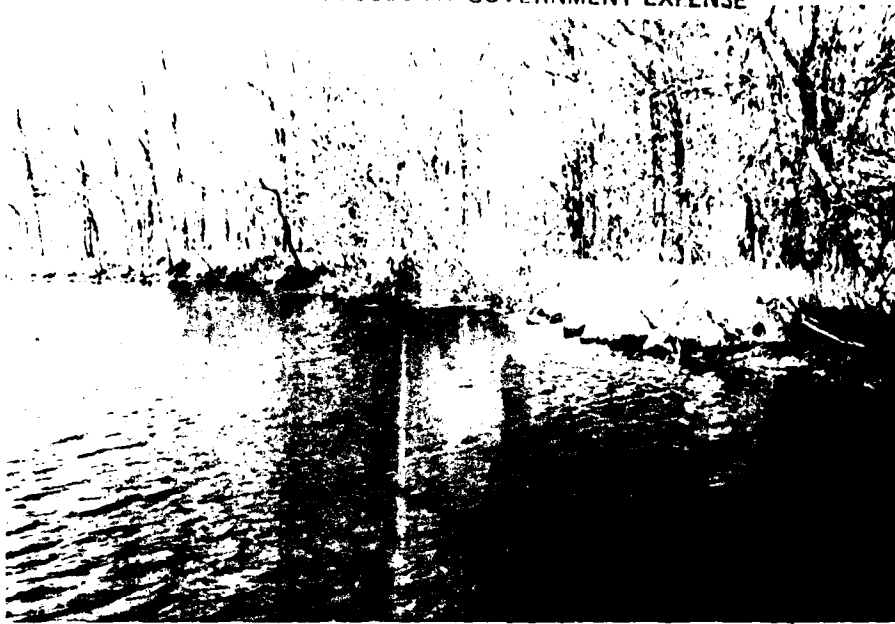
11. Upstream slope of low dike.
